SEQUOYAH NUCLEAR PLANT (SQN) UNIT 2, NRC BULLETIN 2003-02,  
"LEAKAGE FROM REACTOR PRESSURE VESSEL LOWER HEAD  
PENETRATIONS AND REACTOR COOLANT PRESSURE BOUNDARY  
INTEGRITY," (TAC No. MC0564) AND NRC ORDER EA-03-009 -  
INTERIM INSPECTION REQUIREMENTS FOR REACTOR PRESSURE VESSEL  
HEADS AT PRESSURIZED WATER REACTORS

Reactor Pressure Vessel (RPV)  
Lower Head Examination Results  
(Excerpts from Report No. BOP-2448)

REACTOR PRESSURE VESSEL  
LOWER HEADREMOTE VISUAL (VT-2)  
BIM PENETRATION EXAMINATION

**Sequoyah Unit 2, Cycle 12 – RPV Lower Head  
Remote Visual Penetration Examination Final Report**

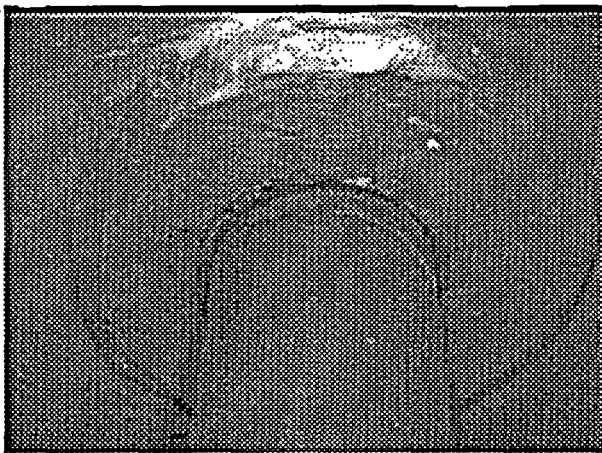
The overall condition of the bare head surface was very clean, with minimal coating degradation. The surface of the head and the instrumentation tubing exhibited markings consistent with construction activities. Ref: Section 3: Figure No's: 3 through 12

Figure 3 – BMI No. 25  
General Condition

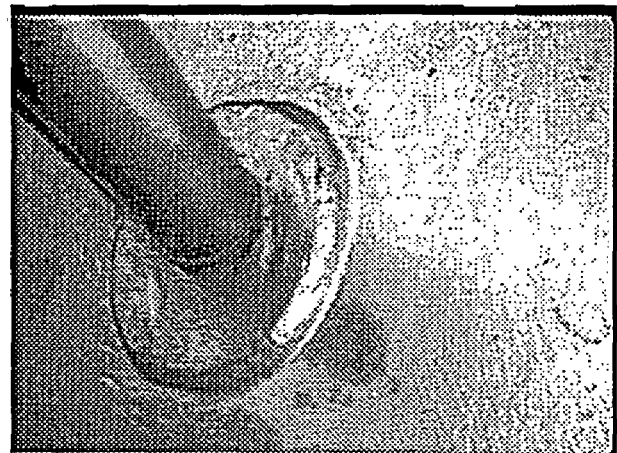
Figure 4 – BMI 26  
General Condition

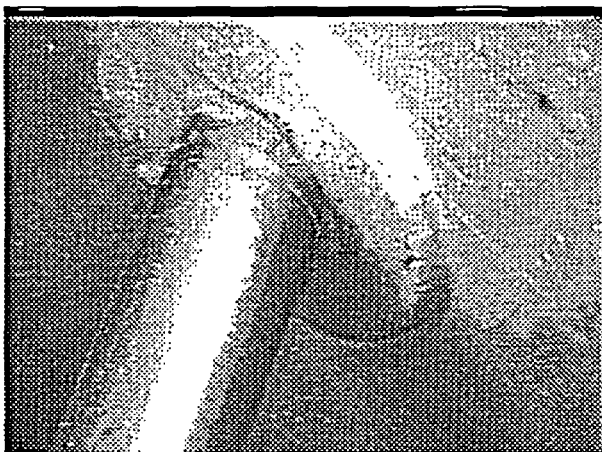
Figure 5 – BMI 26  
General Condition

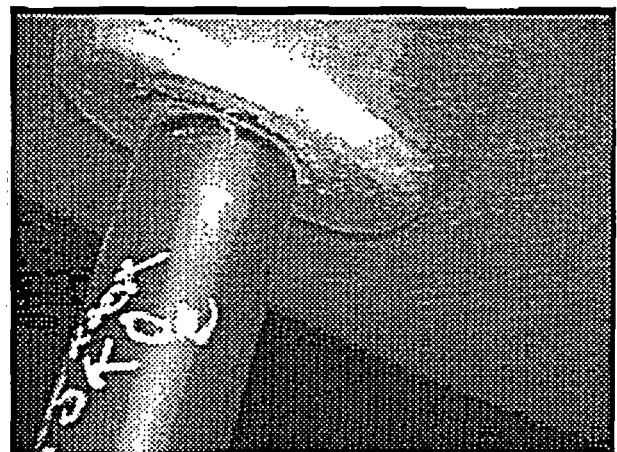
Figure 6 – BMI 33  
General Condition

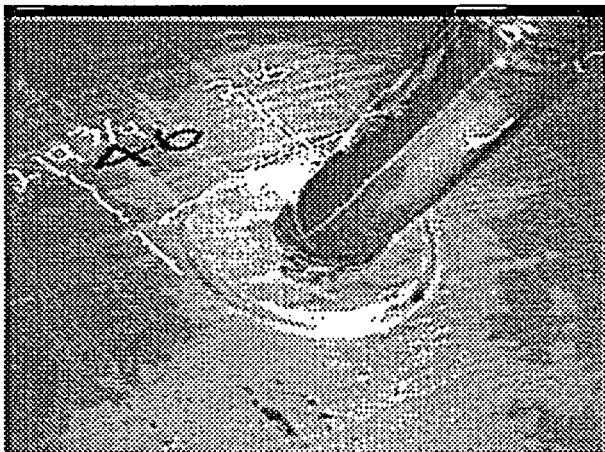
Figure 7 – BMI 46  
General Condition

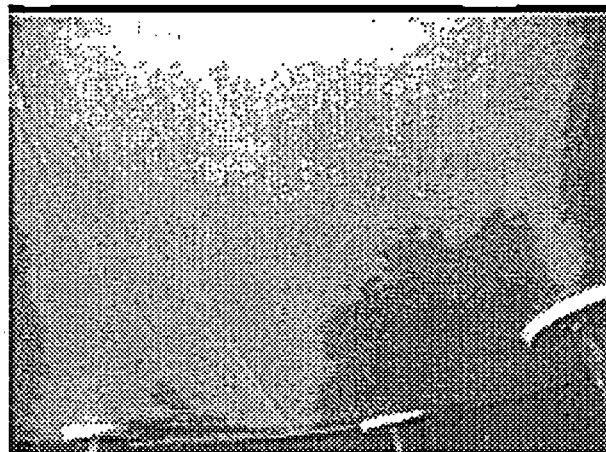
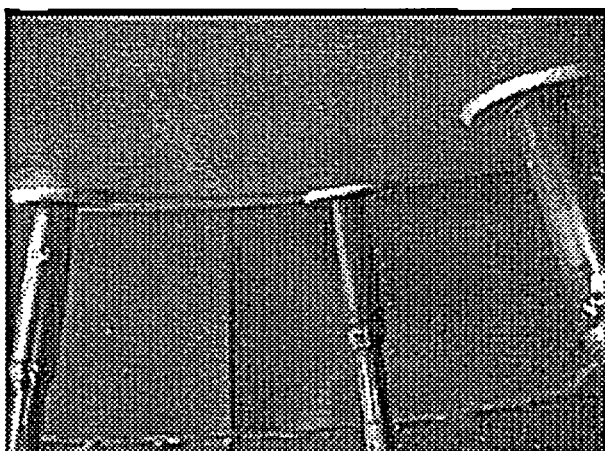
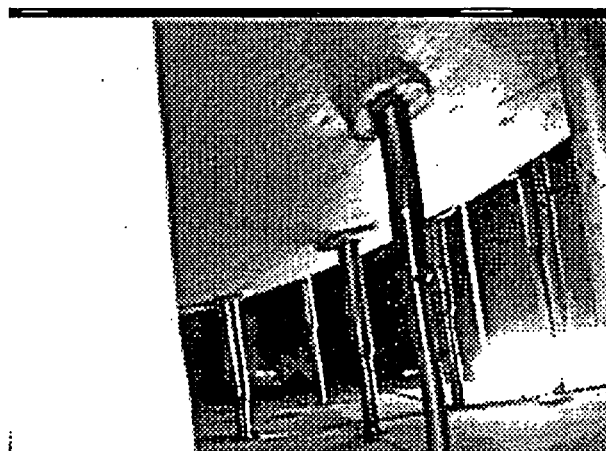
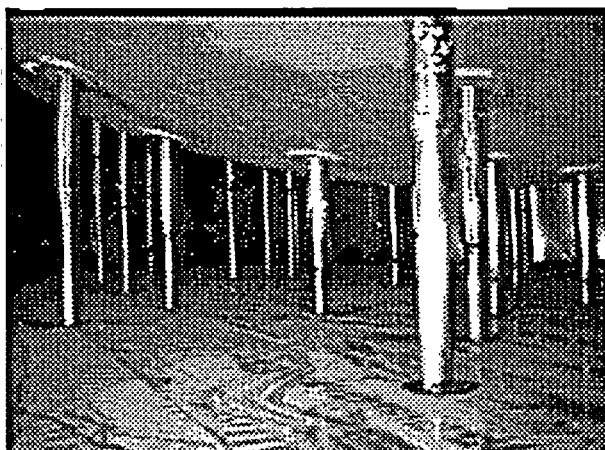
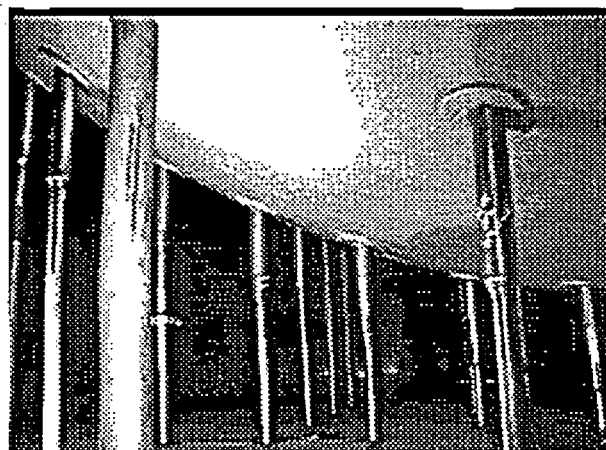
Figure 8  
General Lower Head Surface Condition

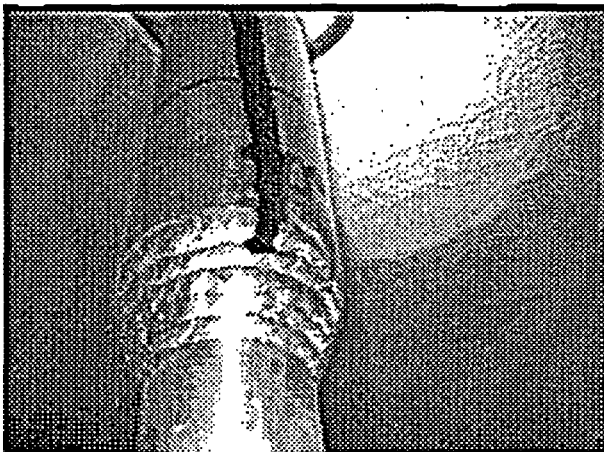
A dark stain was observed on 25 instrument tubes that originated approximately 1"-2" below the penetration (reference Section 3, Figure No's: 13-16). This condition was reported to site Engineering for evaluation and PER No. 03-016523-000 was generated to document the condition.

**Figure 13 – BMI 23**  
General View of Black Coating/Stain

Discussions with site personnel involved in the construction phase of SQN have led to the determination that the substance described as dark and "tar-like" is most likely residue from flagging tape (non-adhesive) used for identification purposes. The flagging was not removed prior to startup and has consequently melted and adhered to the surface of the guide tubes.

The chemical analysis performed on this residue does indicate the presence of some fluorides, chlorides, and sulfates. An accurate measurement of total halogens and sulfates associated with this residue could not be qualified due to the irregular nature of the surfaces (small diameter pipe) and the difficulty in obtaining the samples. However, the quantities reported do not appear to

Stress corrosion cracking of the BMI's is not believed to be an issue due to the residual material from the flagging material based on the above evaluation. In order to further substantiate this determination, a liquid penetrant examination using the fluorescent water washable method (N-PT-7) has been performed on three guide tubes (#26, #30, and #46). No recordable indications were identified during the non-destructive examination. Final disposition of this issue is documented in PER 03-16523.

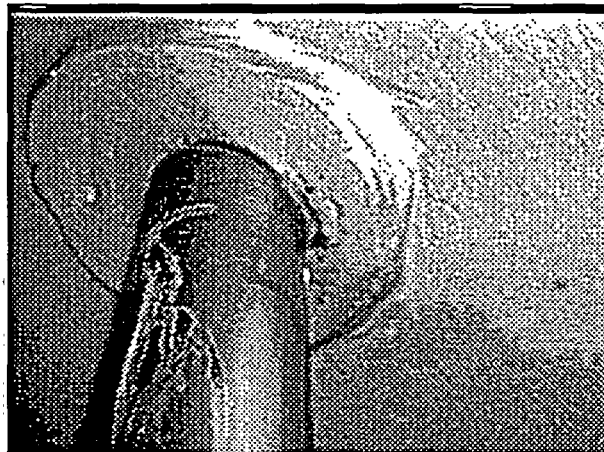
**Figure 14 – BMI 24**  
General View of Black Coating/Stain

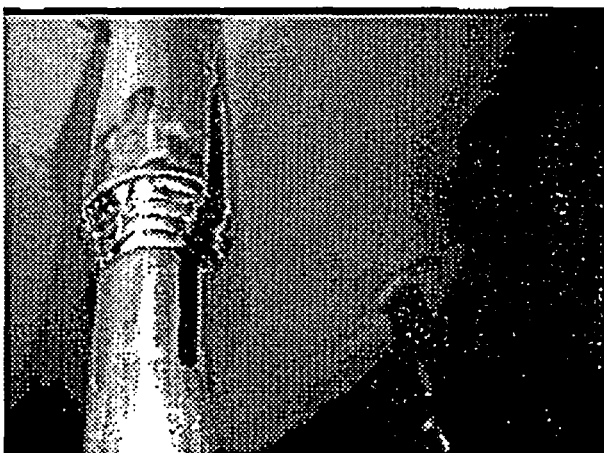
**Figure 15 – BMI 24**  
General View of Black Coating/Stain

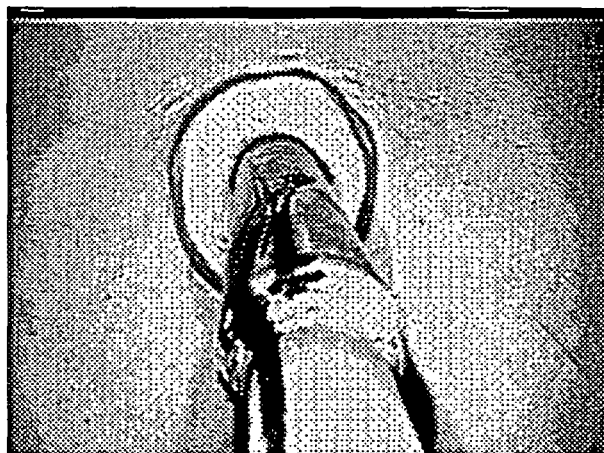
**Figure 16 – BMI 25**  
General View of Black Coating/Stain
